Playgrounds

THE SITUATION

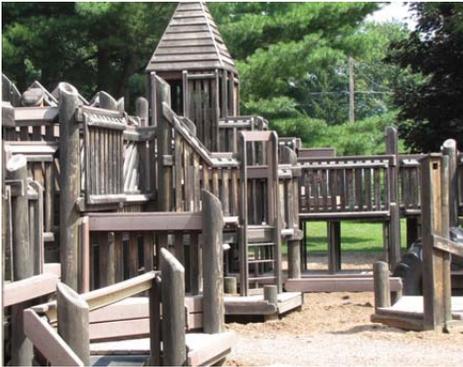
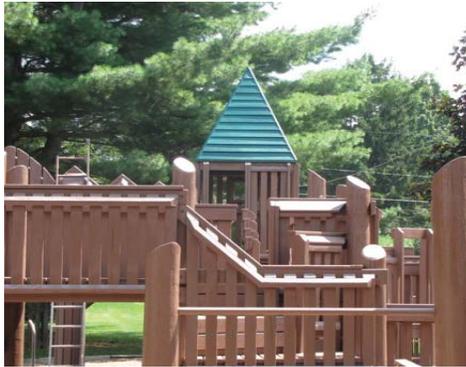
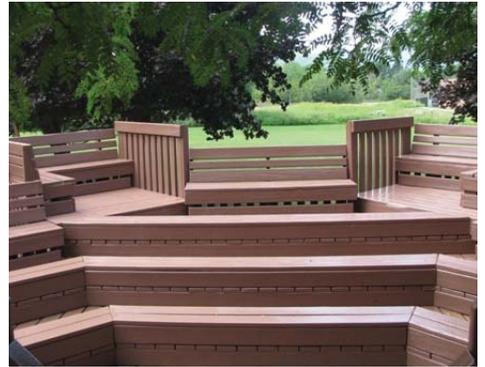
Each piece of pressure-treated wood was coated with LINE-X XS-100 according to the PTA's specifications. The application required approximately one week for two applicators to complete, spraying only in the evenings in order to avoid the moisture from dew.

The LINE-X application is an excellent solution for the pressure-treated wooden playgrounds. LINE-X XS-100 provides an aesthetically appealing appearance, keeps children safe by preventing the wood from splintering, and meets NY State regulations.

- Sawdust moved away from footings and other areas where the structure was close to the ground to allow for easier LINE-X application.
- Footings are cleaned of dirt and contaminants to provide a better surface for LINE-X to bond to.
- Nearby fencing was removed to protect it from overspray, and then reinstalled once the application was completed.

LINE-X masked areas that were not going to be coated, such as chains. LINE-X XS-100 was used due to its excellent bonding abilities to pressure-treated wood. Every piece of wood was coated on all sides. The applicators started applying the coating to the highest surfaces and moved downward. This way, overspray gets on all the lower surfaces and provides plenty of texture. For enclosed areas such as cubbies, the outside was sprayed first. Skid resistance was not required so texture was minimal to normal.
